**Transit Cooperative Research Program**  
Sponsored by the Federal Transit Administration  
**RESEARCH RESULTS DIGEST**

November 2002—Number 51

## **Second Train Coming Warning Sign Demonstration Projects**

*This TCRP digest summarizes the results of two demonstration projects concerning second train coming warning signs for light rail transit systems. The demonstrations were conducted at the Maryland Mass Transit Administration (MTA) and the Los Angeles County Metropolitan Transportation Authority (LACMTA), and were administered by the Federal Transit Administration with funding through TCRP Project A-5A, "Active Train Coming/Second Train Coming Sign Demonstration Project." The MTA report was prepared by Sabra, Wang, & Associates, Inc. The LACMTA report was prepared by PB Farradyne.*

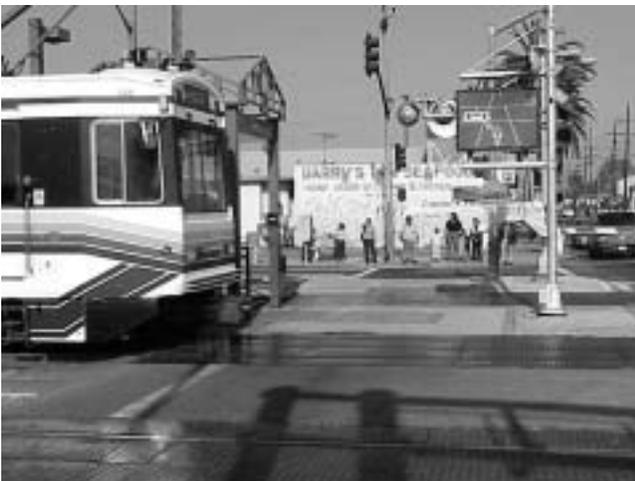
*Figure 1. View of Installed Second Train Warning Sign Looking West.*

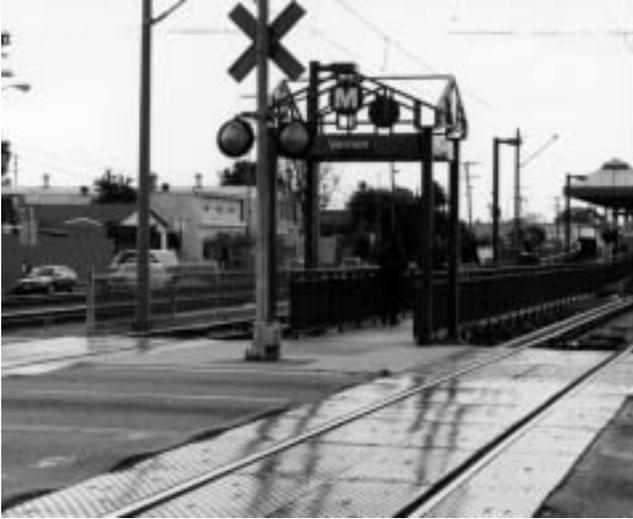
Figure 2. View of Vernon Avenue Highway-Railroad Intersection.

ried out on the south side sidewalk at the Vernon Avenue crossing of the MBL and adjacent freight railroad tracks owned and maintained by the UPRR. The sidewalk crosses two LRT tracks, one normally NB and one normally SB, and two UPRR freight tracks. The entrance to the Vernon Avenue station is located between the normally NB and normally SB LRT tracks. See Figure 2.

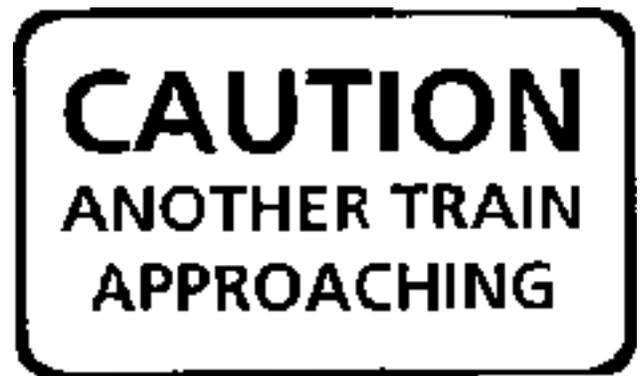
Figure 5. Text Sign 2.

The second text sign consisted of a static message, CAUTION ANOTHER TRAIN APPROACHING, activated when two trains were at or in the vicinity of the Vernon Avenue HRI. This wording was selected for further testing because of the possibility of up to four trains at the same

time at the Vernon Avenue HRI. The second text sign is shown in Figure 5.

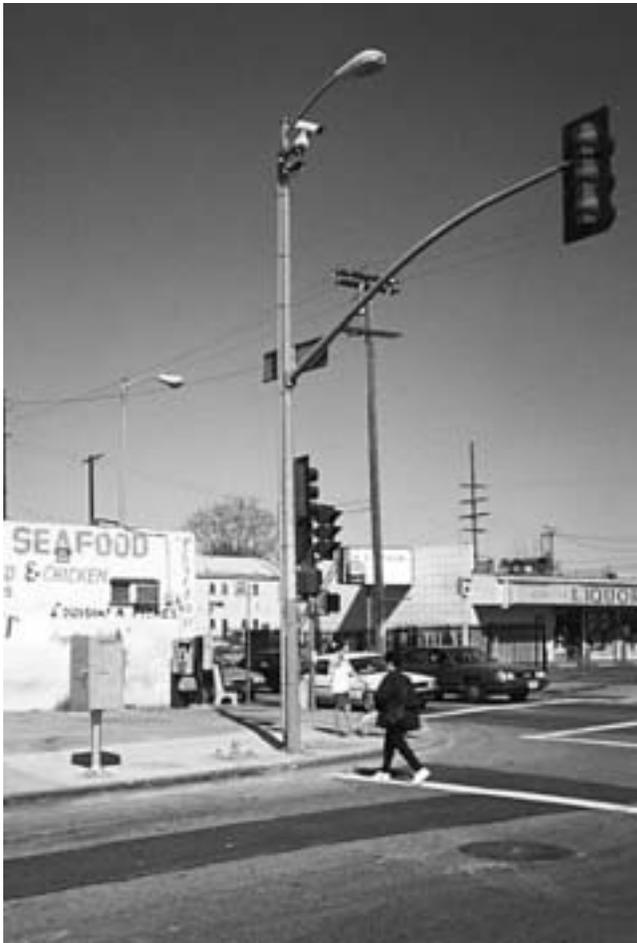
Figure 10. Video Camera Installed at Vernon Avenue.

A video camera was installed in the southwest corner of Vernon Avenue and Long Beach Avenue West. The existing traffic signal pole at this location was replaced with a tall traffic signal pole that provides for mounting of the camera unit at the top of the pole. This location has provided a clear view of the track area for video observation and data collection.

Subsequently, the collected video data was observed and analyzed by a traffic engineer, who was trained to understand the project. Training and consistency were two important factors in the data collection in order to derive meaningful and accurate results. See Figure 10.

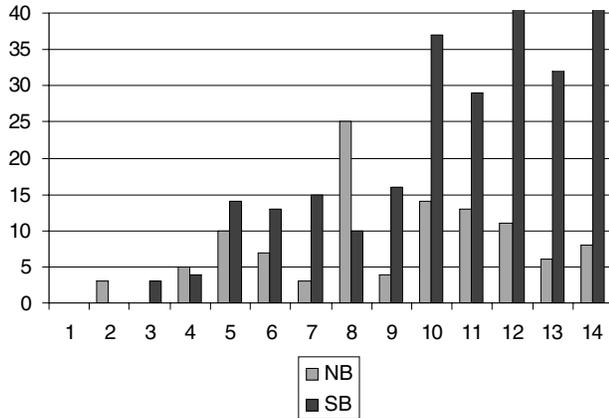
Figure 12. Breakdown of Pedestrian Risky Crossing Times Before Installation.

A total of 380 pedestrians were observed crossing the LRT tracks at less than 15 seconds in front of an approaching LRT train. Table 5 summarizes the breakdown of pedestrian crossing times, less than 15 seconds, for each train direction. Figure 12 shows the same data in a graphic format.

There is a noticeable spike at eight seconds for NB risky crossings. One group of seven pedestrians crossing at the same time is included in this category.

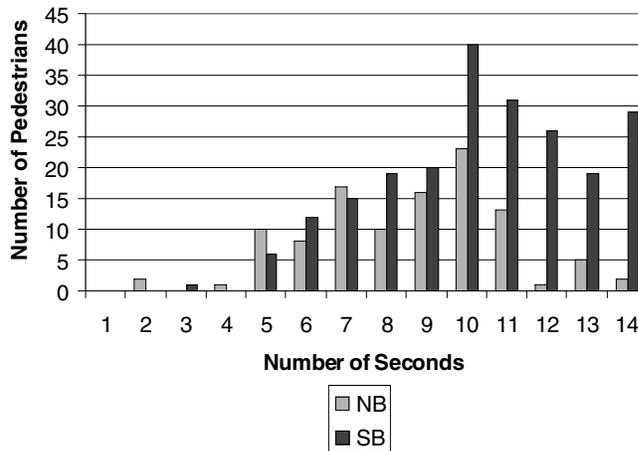
Figure 14. Breakdown of Pedestrian Risky Crossing Times After Installation.

A total of 326 pedestrians were observed crossing the LRT tracks at less than 15 seconds in front of an approaching LRT train after the warning sign was installed. This was a reduction of 14 percent in the total number of risky pedestrian crossings. Table 8 summarizes the breakdown of pedestrian crossing times, less than 15 seconds, for each train direction. Figure 14 shows the same data graphically.

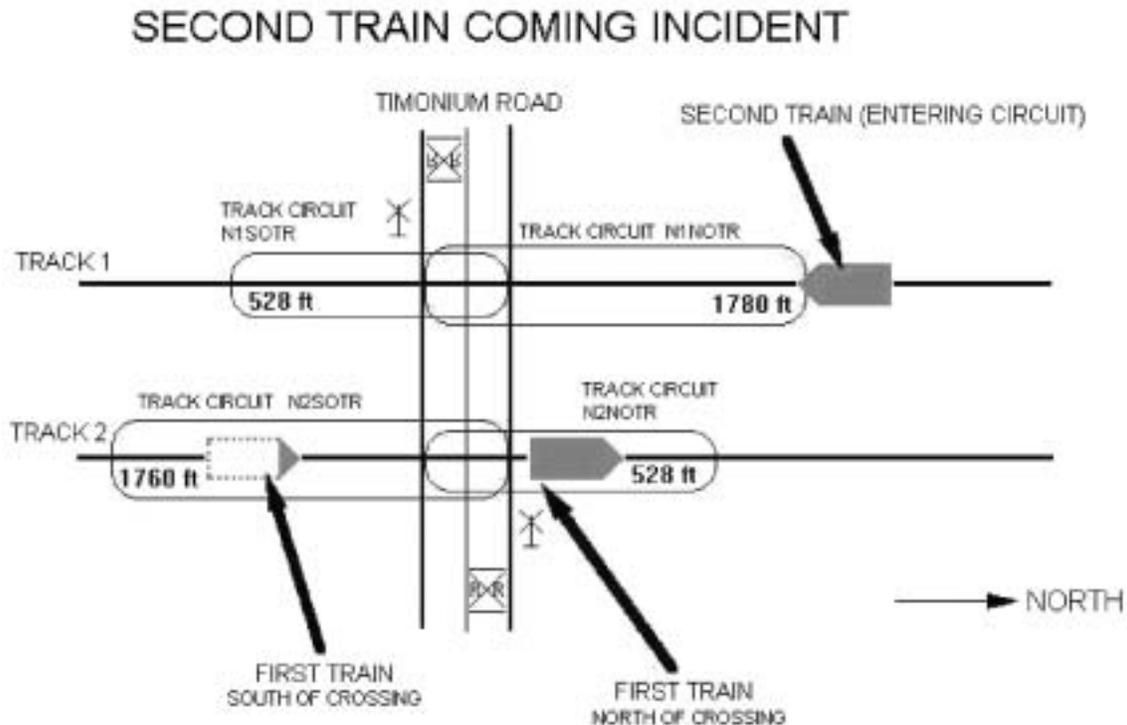
Figure 2. Schematic of Gate Activation Circuits.

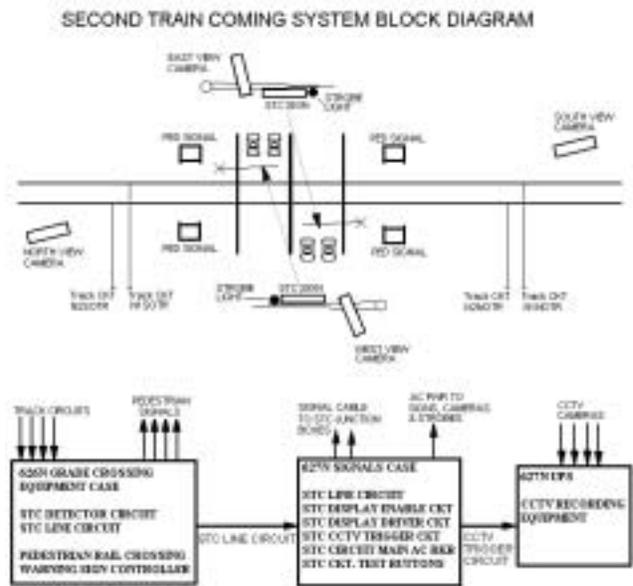
Figure 4. STC System Block Diagram.

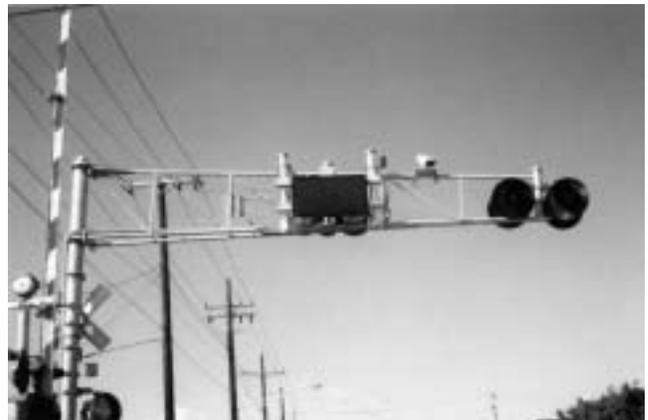
*Figure A-5. Overhead LED blank-out sign with warning flasher and CCTV for data recording.*

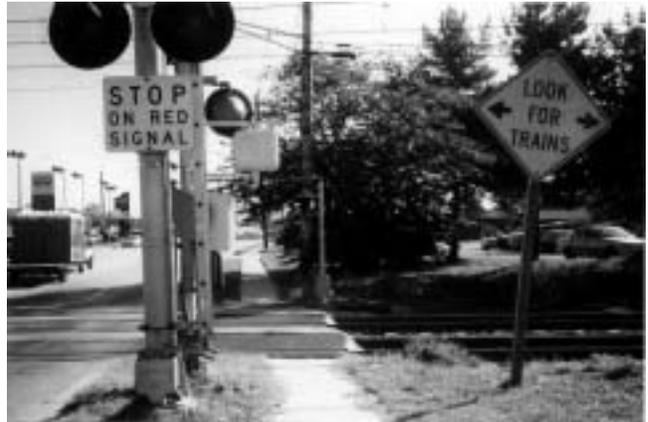
*Figure A-6. Pedestrian signals and warning sign — south leg.*

Wayside Instrument Case (WIC) 626N. The signals were side mounted on 10-ft breakaway poles. The bases were set on 6-ft-deep concrete foundations. An electrical ground rod was installed and connected to each signal base. The materials used for the signals, masts, bases, and foundations meet the requirements as set by the Maryland State Highway Administration for such equipment. (See Photograph A-6 in Appendix A).

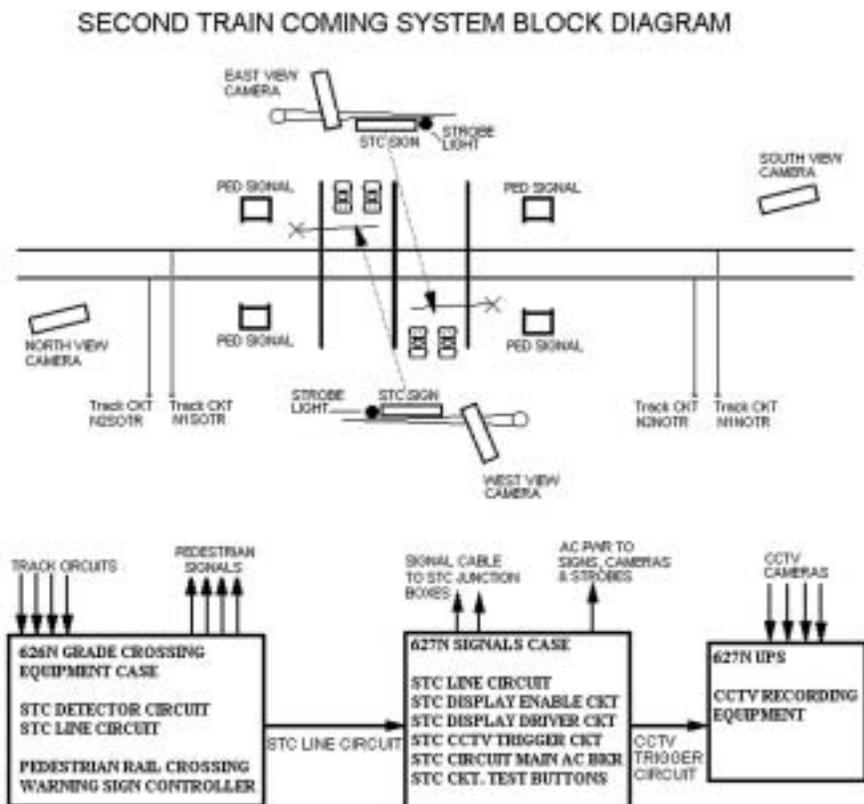
Refer to Figure D-1 (SECOND TRAIN COMING SYSTEM BLOCK DIAGRAM). Note the three wayside buildings in which the electronics are located. Wayside Instrument Case (WIC) 626N has a vital relay circuit (STC) that

senses the second train coming event based on the grade crossing track circuits. A vital circuit at WIC626N controls a repeater relay (STCP) at WIC627N. The electrical connection between WIC626N and WIC627N utilizes existing wires within the MTA's express cable. At WIC627N, two vital relays (STCP, STCDRV) serve to activate the STC graphic signs and strobe lights that are mounted on both grade crossing cantilevers. The same circuitry also triggers the alarm signal to the CCTV recording equipment located inside of the 627N UPS shelter.

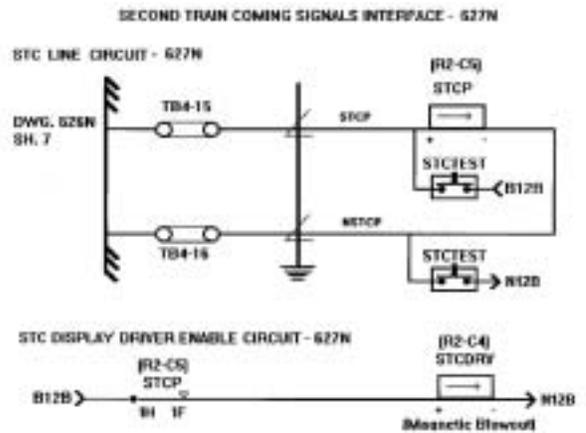
Figure D-5 illustrates relay circuit STCDRV that is energized via STCP contacts 1H, 1F when relay STCP is energized. Relay STCDRV is a magnetic blowout relay that is designed to minimize the arcing associated with the switching of DC power. When relay STCDRV energizes, it enables the STC DISPLAY DRIVER CIRCUIT shown in Figure D-6.

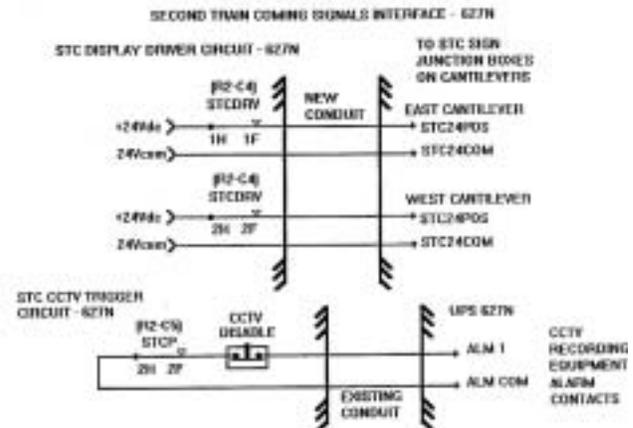
Figure D-6 illustrates the alarm circuit that is used to trigger the CCTV recording equipment inside of the UPS 627N shelter. Note contacts 2H and 2F of relay STCP that will close when relay STCP energizes. The alarm circuit terminates onto the normally open alarm contacts of the VCR inside the UPS 627N shelter. A CCTV DISABLE button is available to prevent VCR recording when performing maintenance testing of the STC warning system. When pressed, the disable button prevents alarming the VCR until it is released.

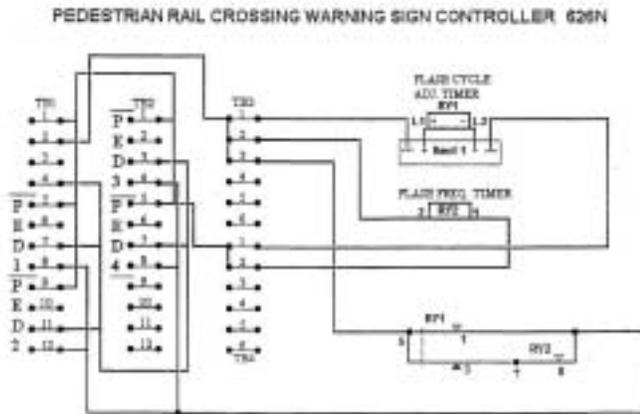
The remaining PED signal control is accomplished within the **PEDESTRIAN RAIL CROSSING WARNING SIGN CONTROLLER** as illustrated in Figure D-11. The controller is responsible for implementing the timing relative to the DON'T WALK cycle. The MUTCD specifies that a PED signal must flash its DON'T WALK icon long enough for pedestrians to vacate the walkway. The timing of the flash interval is based upon how long it takes a pedestrian to cross the entire walkway from sidewalk to sidewalk. At the Timonium Road crossing, the walkway distances are 47 feet and 38 feet. The MUTCD specifies a pedestrian's speed as being 4 feet per second. Therefore, 13 seconds was chosen as the flash interval to be well within the MUTCD guidelines. When the WALK relay de-energizes, 120VAC is switched from its 1F contact to its 1B contact as shown in Figure D-10. This causes 120 VAC to be applied to TB1-2 of the controller. Figure D-11 further illustrates terminal strip TB1 within the controller. Note that TB1-2 is wired to TB3-1 and to rectifier **RECT1**. Observe that the **FLASH CYCLE ADJ. TIMER RY1** receives 120 VDC via

**RECT1**. Relay timer RY1 delays the closing of its contacts until its 13-second time delay expires. Note RY1's contacts 5 and 3 on Figure D-11, which provide a path for 120 VAC to illuminate the DON'T WALK icons during the flash interval. When the 13-second time expires, relay RY1 energizes and RY1's contacts 5 and 1 provide the 120 VAC to illuminate the DON'T WALK icons in the steady state. The flashing of the DON'T WALK icons is accomplished via contacts 7 and 8 of **FLASH FREQ. TIMER RY2**. Relay RY2 opens and closes its contacts slightly less than once every second. Relay RY2's flash time is adjustable and is set to provide an appropriate on/off time for the DON'T WALK icons. Figure D-12 details the component layout of the controller.
