Research Results Digest 84

AUDIBLE SIGNALS FOR PEDESTRIAN SAFETY IN LRT ENVIRONMENTS

This digest summarizes the results of TCRP Project D-10. The digest was prepared by Korve Engineering, A Division of DMJM Harris, in conjunction with ATS Consulting, LLC; Fidell Associates; Center for Education and Research in Safety; and Bear Consulting.

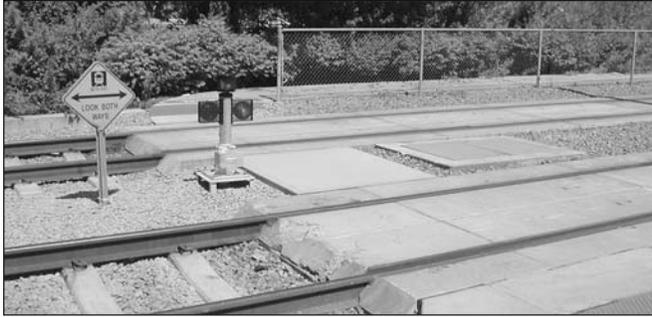
Figure 5 Portland Tri-Met “Mini” Pedestrian Crossing Device.

4.4.1.2 Mini Devices. Three transit agencies use a Mini (low-rise) pedestrian device at some pedestrian-only crossings. Figure 5 shows a Mini device installed on the Westside Line on Portland's Tri-Met system. Tri-Met has this device installed at 28th Street and at S.W. Baseline Road. Devices similar to the Tri-Met device have been installed between tracks at crossings along the triple-track section of the BNSF main line in Chicago, Illinois, where Metra commuter rail service operates.

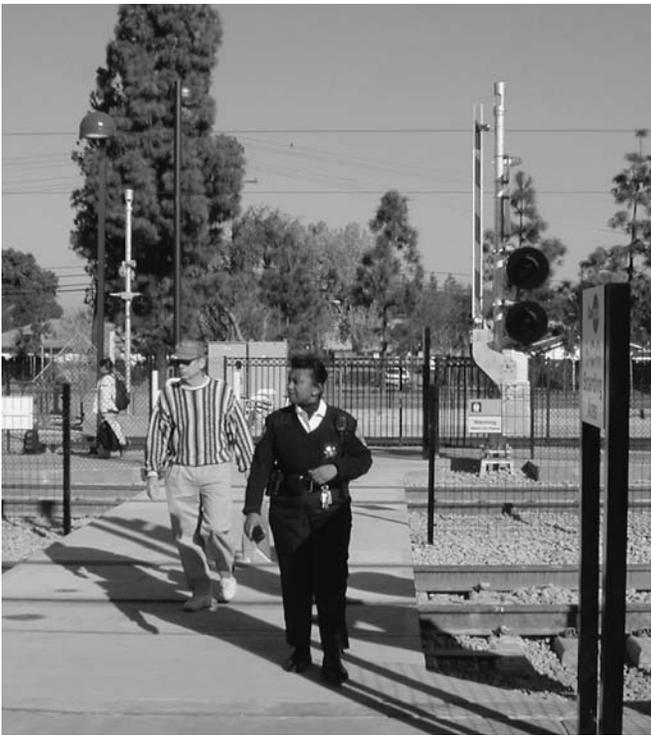
Figure 8 Vertical Mounted Flashing Light Device with Audible.

The Peninsula Corridor Joint Power Board (Caltrain) has installed a flashing light device with pedestrian crossing gates on the Tasman West light rail line at the Downtown Mountain View transit center (see Figure 8). This device is intended to control foot traffic between the bus transit center and the LRT platform across the Caltrain commuter rail tracks. The Mountain View device has the flashing light assembly mounted vertically instead of horizontally. (The MUTCD railroad committee has proposed language in process to allow mounting the flashing light assembly in this configuration.)
