IDEA PROJECT FINAL REPORT

Contract TRANSIT-17

**Operational Evaluation of
a Rail-Based Wheel Gauge
Inspection System**

Zack Mian
International Electronic Machines Corporation

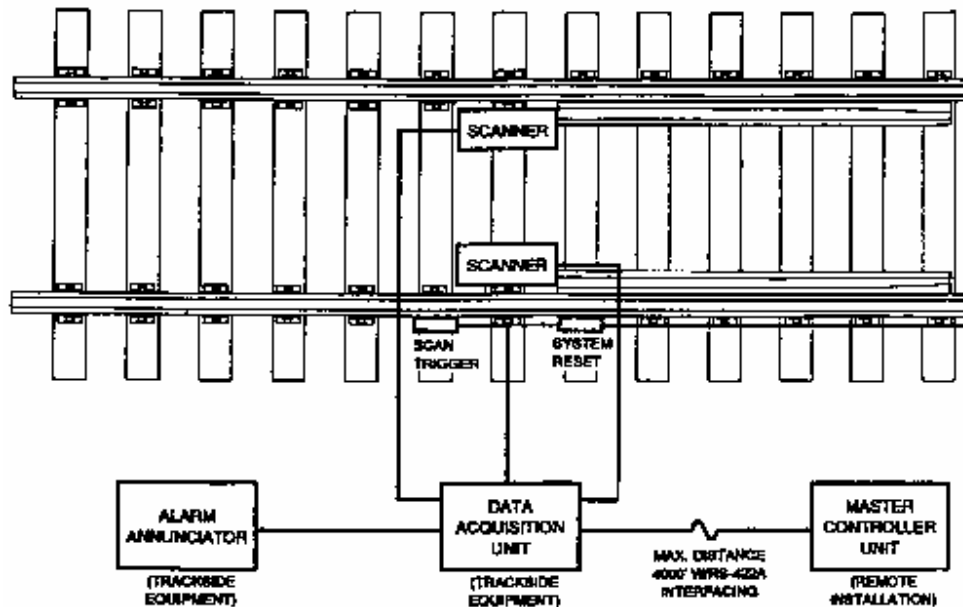
Figure 1: Wheel inspection station - schematic drawing.

IEM has developed a high speed laser scanning approach using: acousto-optics, line generating optics, image capturing, and graphic analysis software. This combination captures cross-sectional wheel profile images at high speeds and converts them to standard wheel measurements. We have added distance from the reference diameter groove and a calculation of flange angle to the traditional measurements of flange thickness, flange height and rim thickness. The flange angle measurement is vital to the determination of wheel/rail interaction and the maintenance of acceptable train dynamic conditions.

The laser beam illuminates the wheel. Then, the system captures and brings the image into the digital computer environment. Finally, the wheel profile analysis software converts the raw image into standard wheel measurements. In the production mode, this entire process is invisible to the operator and he would only see a report listing the worn wheels, their location and the type of wear.

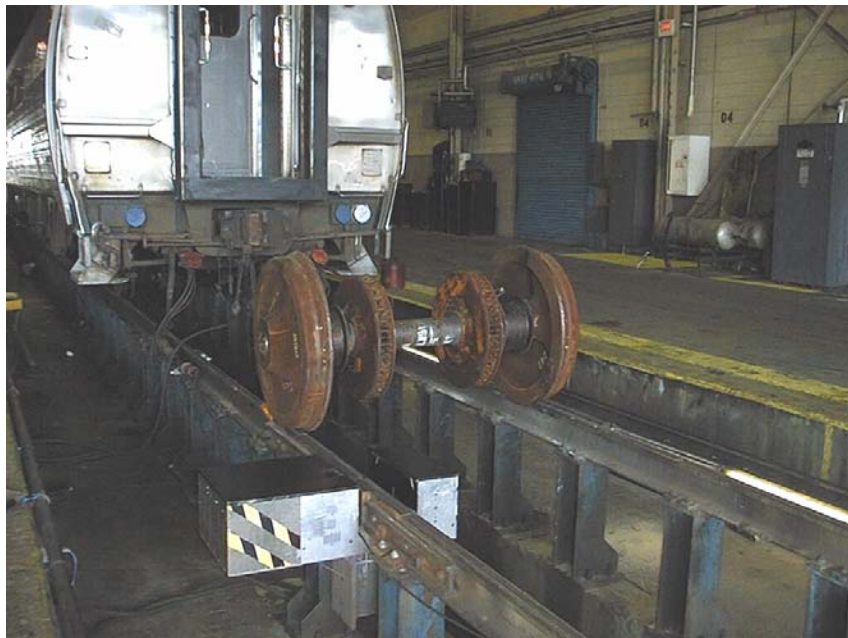
Figure 4: Profile system.

A custom rail segment was needed for the profile system. IEM designed and fabricated the segment. Stress analysis on the design was done by professional structural engineers. We installed the custom rail segment at Amtrak's Rensselaer site. Figures 3 and 4 show the profile installed at the Rensselaer site.

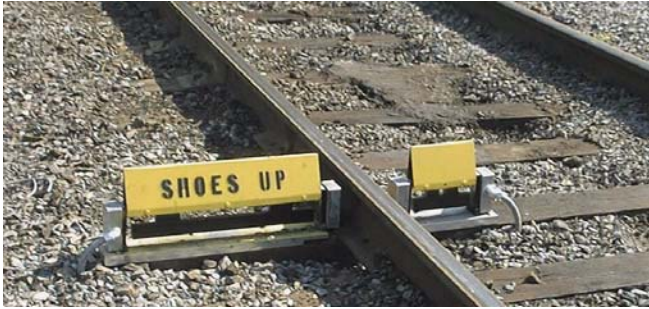
Figure 5: Rotating steel veins.

In order to guard against potential damage done by dragging equipment, we have designed a dragging equipment detector to notify the engineer when dragging equipment from the train is in danger of striking the profile system. Our detector consists of a pair of rotating steel veins attached to an optical encoder (figure 5). The encoder triggers an electronic latching circuit which turns on a red quartz caution light and an 85-decibel horn (figure 6). We mounded the detector approximately 40 yards down rail from the east entrance to the track. The light and horn are mounted at the east end of the track pit. They are within close proximity to the laborer who is responsible for guiding the train. It is the laborer's responsibility to notify

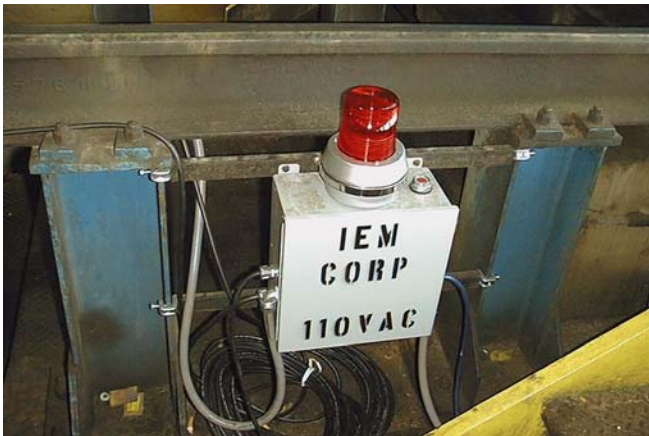
Figure 6: Caution light and 85-decibel horn.

the engineer by radio to stop the train should the detector be tripped.
