## **Recoating Electrified Third Rail Cover Boards - Phase 2**

Final Report for  
Transit IDEA Project 59

Prepared by:  
Arun Vohra, P.E.  
MINI LLC  
Bethesda, MD

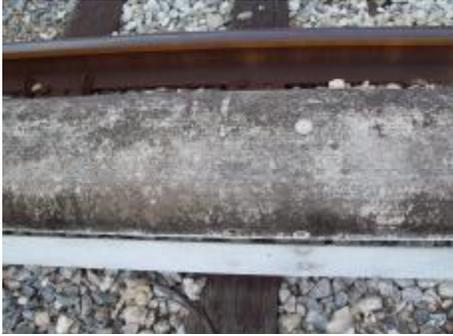
Deteriorated cover board,  
Miami, July 2009

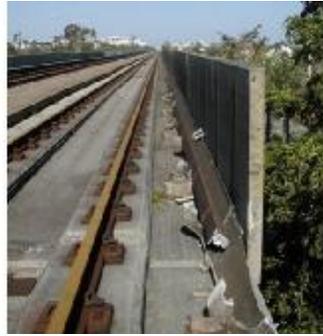
Cover board blown off along with third rail  
during Hurricane Wilma, Miami, October 2005

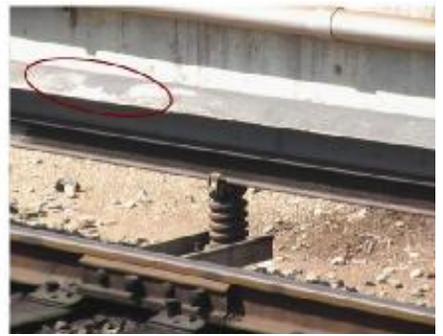
BART Gel Coat deteriorated on cover board,  
21 July, 2006

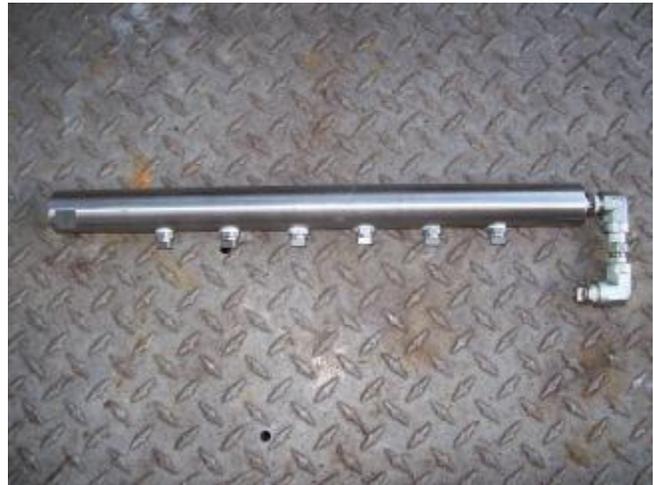
Fig 1. Spray bar with 7 nozzles

A cover board cleaning system was developed. The purpose was to clean the cover boards in place before applying the coating. Two high speed cleaning methods, a spray bar and a spinning bar, were considered. The purpose was to clean the cover board surface in one pass, before applying the coating. A pressure washing spray bar with 7 fan jet spray nozzles, was fabricated and tested. It was determined that the spray bar would need excessive water flow to properly supply all 7 nozzles and was deemed to be impractical with the equipment available.

Two high speed cleaning methods, a spray bar and a spinning bar, were considered. The purpose was to clean the cover board surface in one pass, before applying the coating. A pressure washing spray bar with 7 fan jet spray nozzles, was fabricated and tested. It was determined that the spray bar would need excessive water flow to properly supply all 7 nozzles.

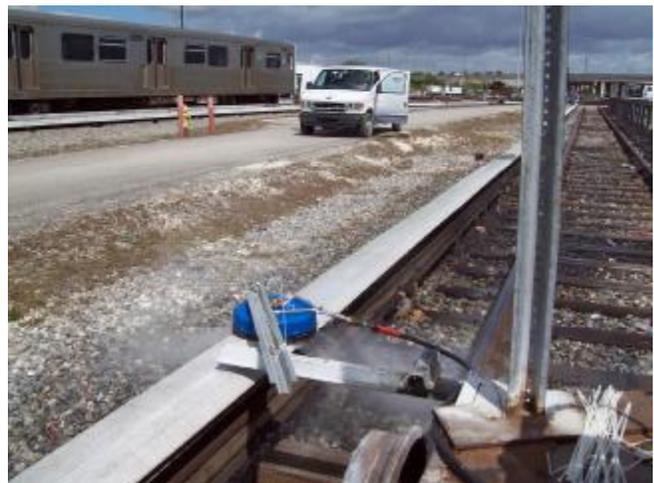
Fig 3. Spinning bar with 2 nozzles for improved cleaning

An improved cleaning system was tested. A pressure washer was attached to a surface cleaner consisting of a swivel that had two hollow arms with an offset round jet nozzle at the ends. The reaction force of the water jets at the nozzles caused the arms to spin. The pressure washer was carried on a service vehicle and the surface cleaner was attached to an arm positioned on the cover board. The service vehicle was moved along the track to test clean a section of cover board. The dwell time and the standoff distance of the spinning water jets were found to clean the cover board satisfactorily in one pass.

An improved cleaning system was tested. A pressure washer was attached to a surface cleaner consisting of a swivel that had two hollow arms with an offset round jet nozzle at the ends. The reaction force of the water jets at the nozzles caused the arms to spin. The pressure washer was carried on a service vehicle and the surface cleaner was attached to an arm positioned on the cover board. The service vehicle was moved along the track to test clean a section of cover board. The dwell time and the standoff distance of the spinning water jets were found to clean the cover board satisfactorily in one pass.

Cleaning the cover board by wire brushing was not appropriate as it will pull out the exposed fibers with consequent weakening of the cover board. Compressed air jets are generally adequate to clean moderately dirty cover boards. Very dirty cover boards can be cleaned by pressure washing using a spinning bar.

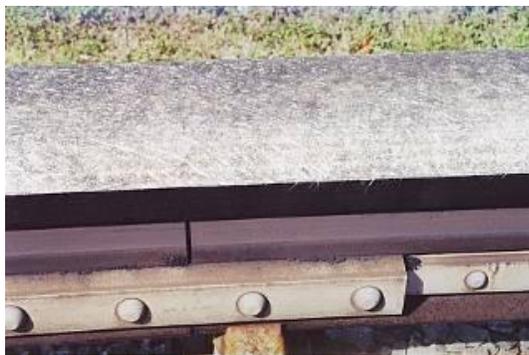
Fig 4. Delaminated glass fibers on cover board after UV damage to gel coat, Miami, Dec 2003

Ultraviolet (UV) rays from sunlight eventually erode the gel coat. Where there are voids on the surface, the glass fibers are exposed and experience fiber bloom. Water ingress into the void, enhanced by wicking action, followed by freeze thaw cycles, results in increased surface damage, exposed fibers and a weakened cover board.

Fiberglass or Fiberglass Resin Polyester (FRP) is polyester resin with reinforcing chopped strand mat (CSM) of glass fibers. The polyester resin does not have enough time to fully wet out or completely saturate the glass mat, as it sets in 10 – 15 minutes. This leaves tiny bubbles or voids on the product surface. The product is coated with a gel coat to protect it from the elements.

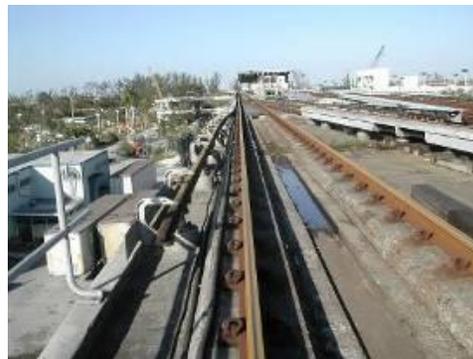
Fig 5. Weakened cover board blown off by Hurricane Wilma, Miami, October 2005

MDT, Miami has 57 miles of elevated and on grade track. The cover boards are severely deteriorated because MDT had no means to periodically recoat the cover boards in the past. MDT estimates that a crew of 8 workers at \$41 per hour per worker can replace 1000 feet of cover board in an 8 hour shift. The labor cost is \$2.60/foot of cover board. The estimated cost of a standard 10 foot piece of 14 inch wide cover board, contiguous 10 foot piece of 7 inch wide back drop, 2 brackets and retaining pins is \$250. The labor and material cost is \$ 27.60/foot of cover and side board. Fringe and night differential labor cost has to be added to the total cost of replacement. As a result of Hurricane Andrew in 1992 and Wilma in 2005, several miles of deteriorated cover
